Manhole Inspection Summary

Manhole # S29E__057MH

Insp Date: **9/25/08 8:31 AM**

Location Address: **220 N. Pine St**

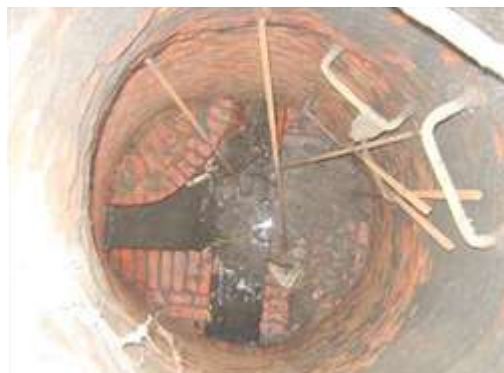
Top View

Debris on bench
Debris in channel

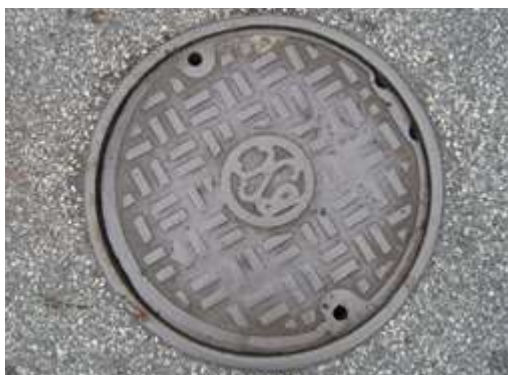
Worn Cover

Condition: **Worn**

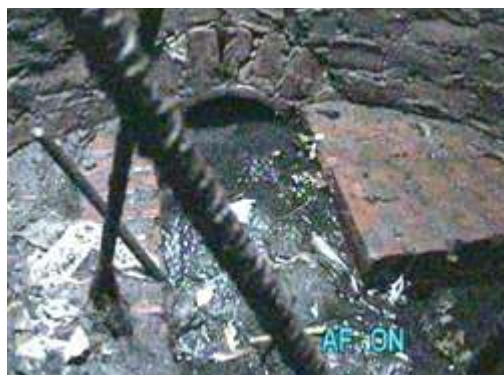
defect

debris in channel and 6 oclk pipe

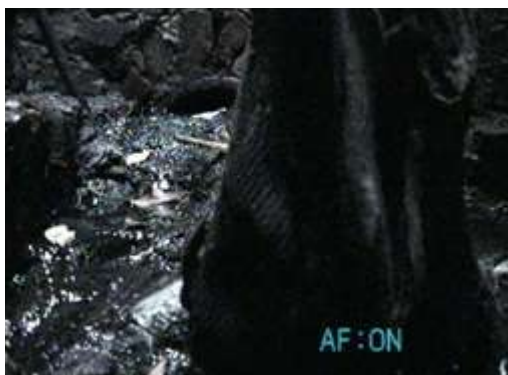
Defect 7

debris in channel

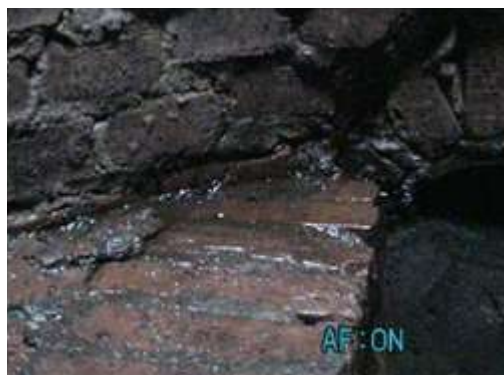
Defect 5

infiltration at barrel/bench joint

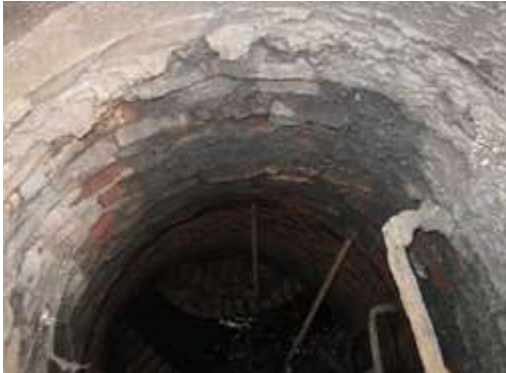
Defect 4

Infiltration from chimney/frame

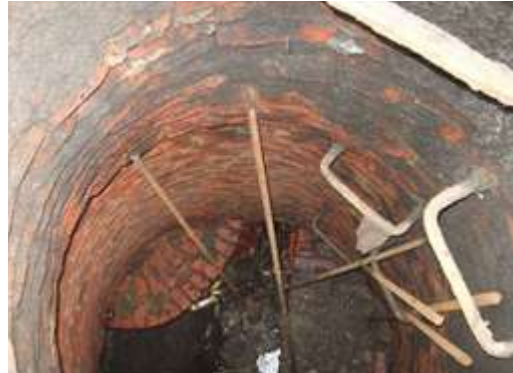
defect

Infiltration from corbel

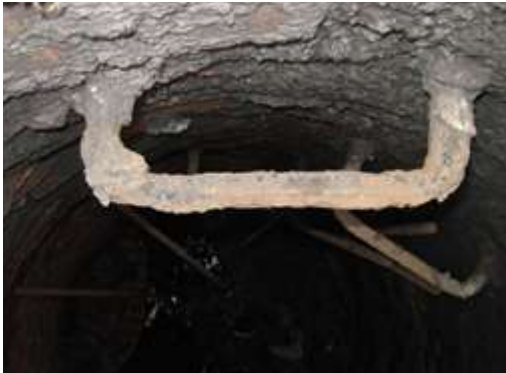
Defect 1

Corroded steps

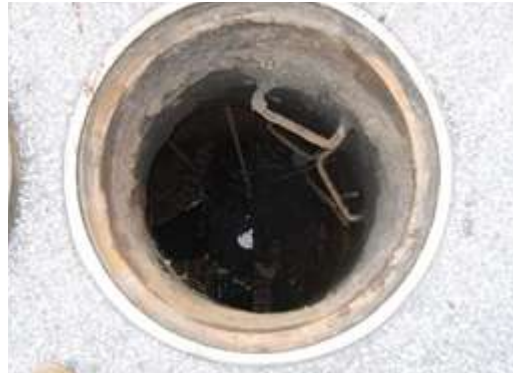
Defect

Infiltration from top

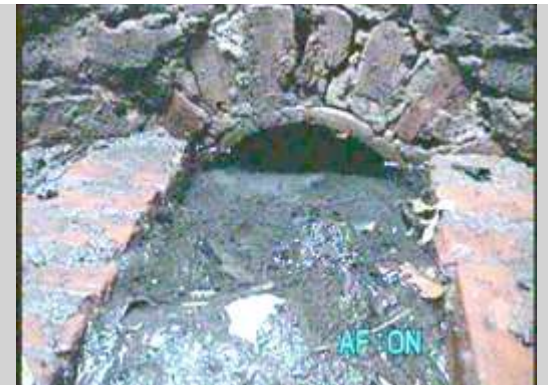
6 O'Clock Inflow

Pipe Height: **10.8** (in.) Rod and Bar (Angled)
Pipe Material: **Clay** ☐ Pipe Lined
Invert Depth: **10.04** (ft.) Flow Characteristics: **Slow**
Deposits: ☐ None ☐ Mud ☒ ~~Gravy~~ ☒ **Debris** ☐ Grease
Silt Depth: **8** (in.) Deposits Extent: **Heavy**
Infiltration: **None** Pipe Seal Cond: **Sound**

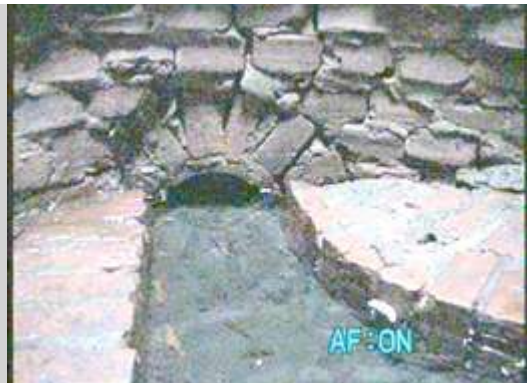
9 O'Clock Inflow

Deposits: ☐ None ☐ Mud ☒ ~~Sludge~~ **Debris** ☐ Grease

Silt Depth: **7** (in.) Deposits Extent: **Heavy**
